ANTI-RUST TREATMENTS

THE FINAL RESULTS

YEAR 3 THE UK'S LONGEST-RUNNING CLASSIC CAR ANTI-RUST TEST

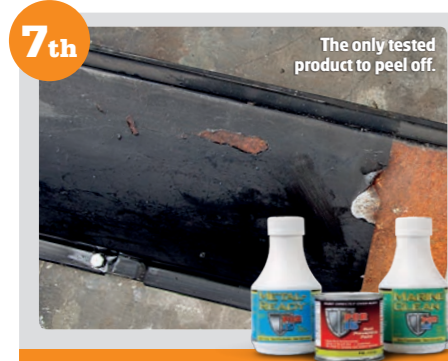
The only tested product to peel off.

POR-15
£21.50 for 473ml

It appeared mostly intact, with a good finish. However, an area near the rusty control strip had lifted slightly. When I checked adhesion the paint layer simply peeled off as a much larger area revealing the metal beneath with tiny rust spots starting to form.

With the exception of POR-15, all the coatings remained intact, demonstrating excellent adhesion. POR might argue the new metal wasn't coarse enough to anchor the paint. But the same goes for all.

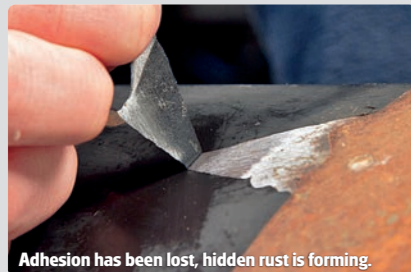
Adhesion has been lost, hidden rust is forming.

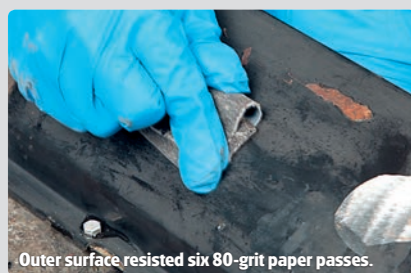
Outer surface resisted six 80-grit paper passes.

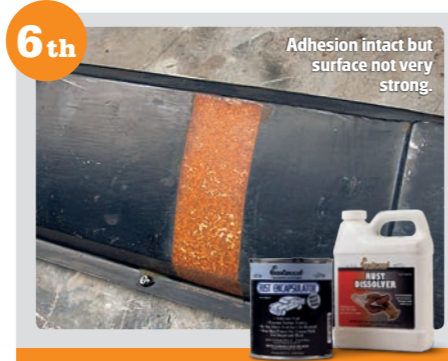
Adhesion intact but surface not very strong.

Eastwood Rust Encapsulator
£30.64 for 469ml

Adhesion seems good at first look. Edges haven't lifted where they meet the control strip. Abrasion broke through easily, though.

Eastwood's Rust Encapsulator had the adhesion but its surface couldn't deal with the light abrasion of 80-grit. All the others resisted the abrasion, including the only primer on test, Electrox. If you need to primer a car and store it before it can be

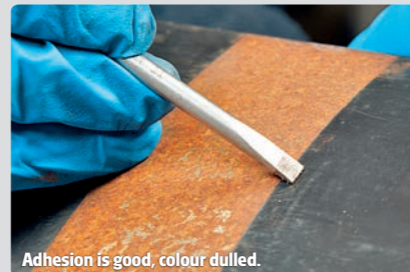
Adhesion is good, colour dulled.

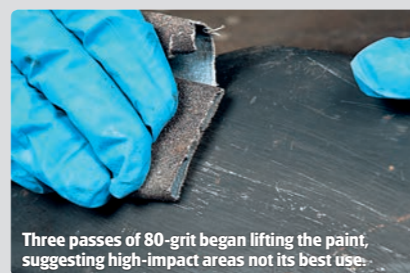
Three passes of 80-grit began lifting the paint, suggesting high-impact areas not its best use.

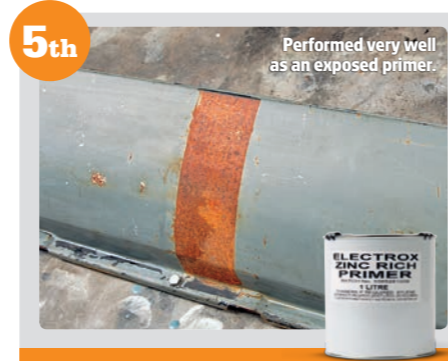
Performed very well as an exposed primer.

Bilt-Hamber Electrox
£29.95 for 1 litre

Excellent adhesion with no breaches even adjacent to rust. Coped very well given that it's a primer minus a topcoat.

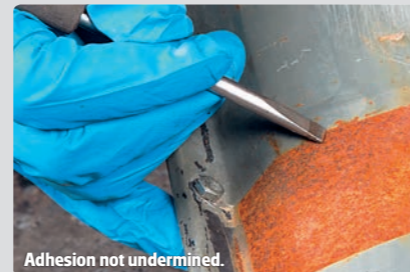
Adhesion not undermined.

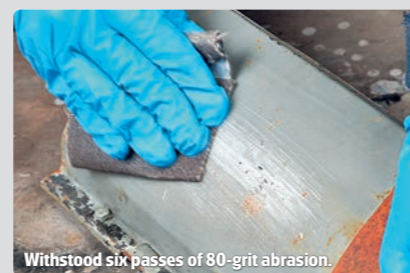
Withstood six passes of 80-grit abrasion.

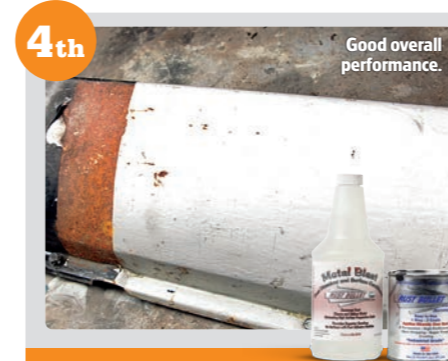
Good overall performance.

Rust Bullet Six Shooter
£43.50 for 946ml

Has stood up well with strong adhesion and no discolouration. Where chipped, it hasn't affected adhesion.

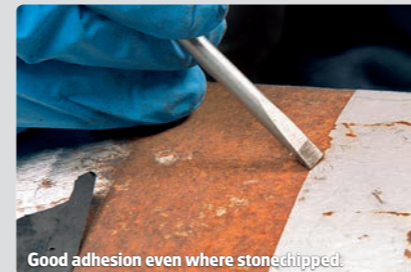
Good adhesion even where stone chipped.

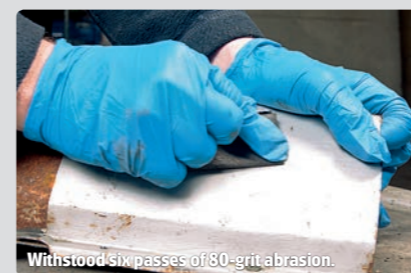
Withstood six passes of 80-grit abrasion.

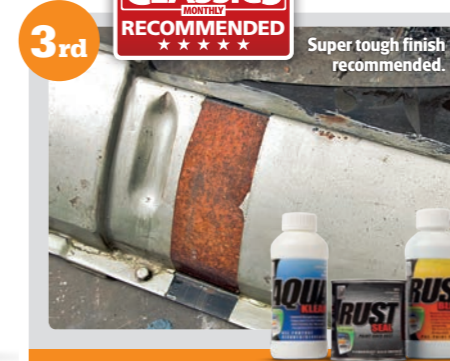
Super tough finish recommended.

Rust Seal
£29.00 for 946ml

Tough as ever finish shows no sign of losing adhesion. The only lift we could find was the masking error on the control strip. If the initial discolouration doesn't bother you, then it could prove ideal.

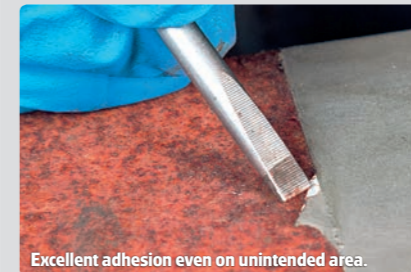
Excellent adhesion even on unintended area.

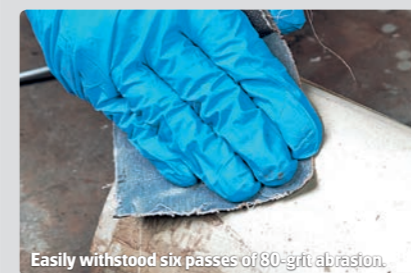
Easily withstood six passes of 80-grit abrasion.

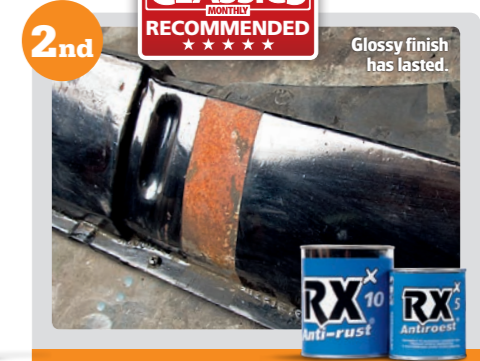
Glossy finish has lasted.

Caprotech RX10
€27.36 for 1 litre

Has performed excellently. Shine still intact, No let up in adhesion and our 80-grit paper only succeeded in scratching it. If a gloss finish is required, RX10 will deliver. The UK distributor has since stopped selling it.

Rust Seal and Rust Bullet both stood up well. The best finish was Caprotech RX10 which surprised me greatly. It looks classy and is super tough. Highly recommended. It also needs a new UK distributor.

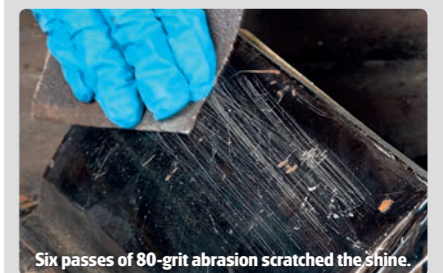
Six passes of 80-grit abrasion scratched the shine.

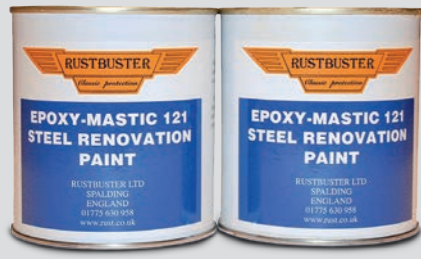
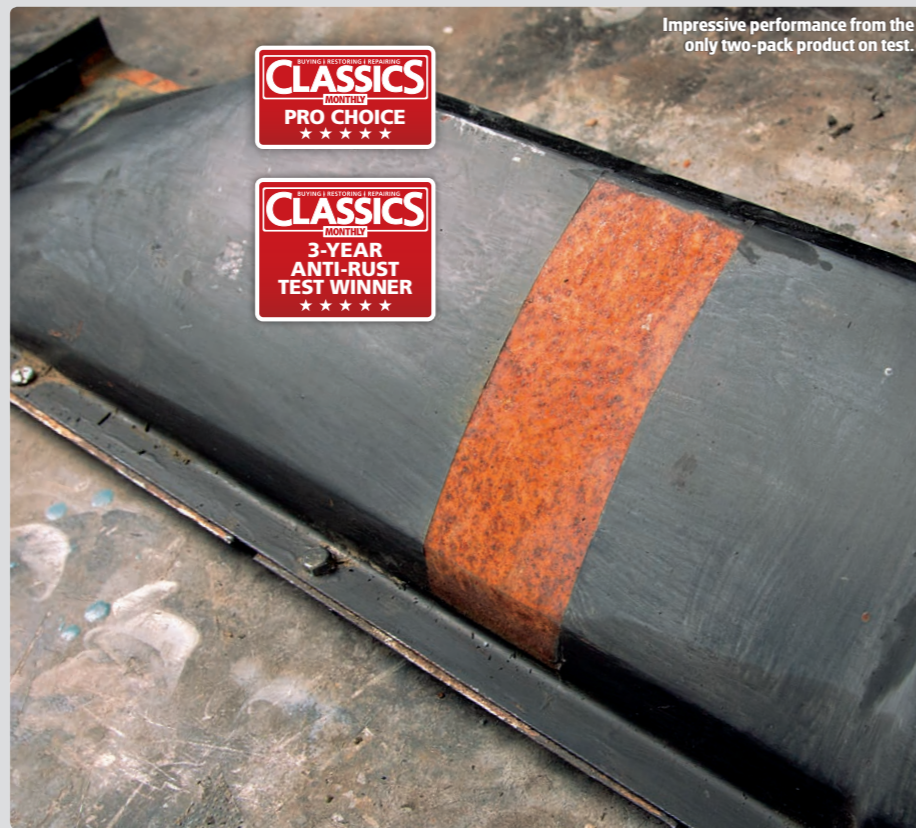
Rustbuster Epoxy-Mastic 121 £25.95 starter pack

Its control strip was the worst on test, but 121 has held firm all around it. No breaching near any edges. It's the least chipped sill on test too, indicative of its toughness. The matt finish has faded slightly but not its resilience.

Impressive performance from the only two-pack product on test.

That leaves the deserving winner, Epoxy Mastic 121. It's a multi-purpose, rustbusting coating of stature. Not only that, it can be overpainted easily, comes in a variety of colours and sizes and will even stick to weathered or T-washed galvanised finishes and non-metal surfaces such as GRP. It can be sprayed once thinned and is perfect for high impact, abrasive areas such as chassis and wheelarches. In three years, we couldn't find a chink in its armour. It sets the highest standard for user-friendly total rust protection.

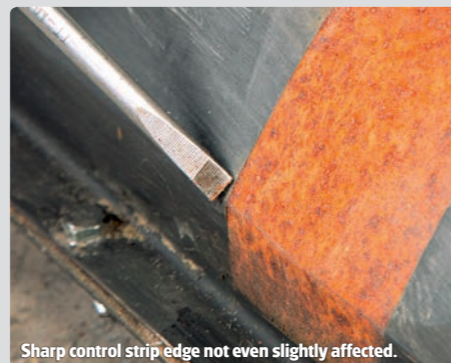
Sharp control strip edge not even slightly affected.

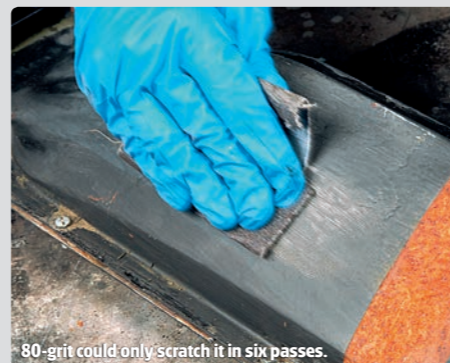
80-grit could only scratch it in six passes.

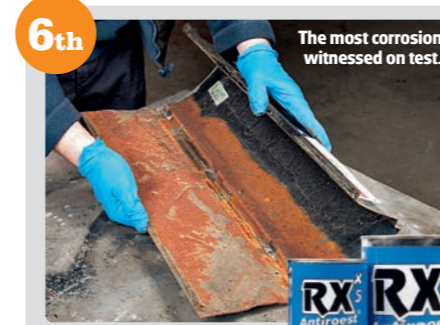
6th

The most corrosion witnessed on test.

Caprotech RX7 €26.84 for 1 litre

Was all but gone from the surface, allowing rust to spread as a very fine coating. The split seam was the worst on test, too. It should be said that no pitting of the metal was evident though. Good for two years but must be reapplied after that.

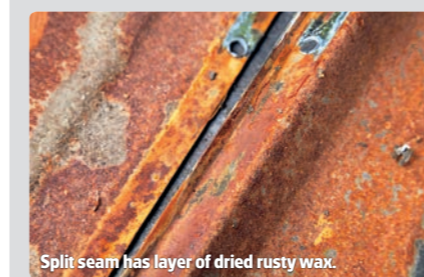
Split seam has layer of dried rusty wax.

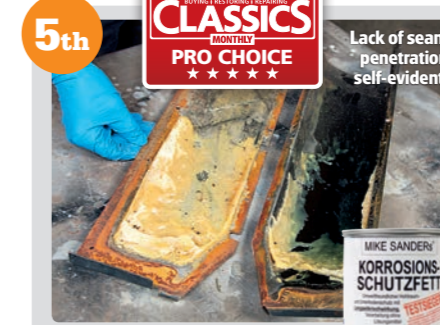
5th

Lack of seam penetration self-evident.

Korrosionsschutzfett €10.50 for 450ml

Incredible protection but its inability to penetrate seams below 120°C is a shame.

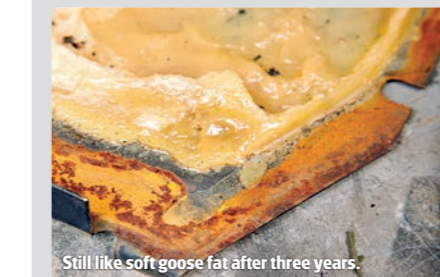
Still like soft goose fat after three years.

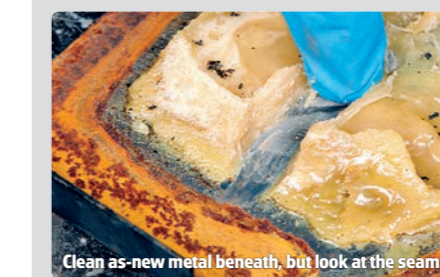
Clean as-new metal beneath, but look at the seam.

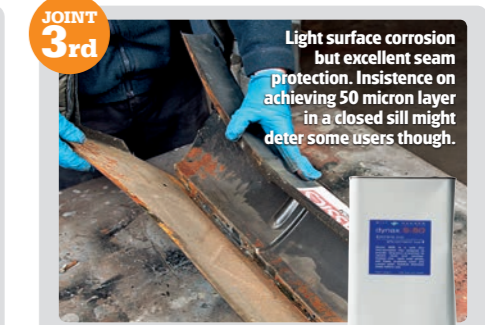
JOINT 3rd

Light surface corrosion but excellent seam protection. Insistence on achieving 50 micron layer in a closed sill might deter some users though.

Bilt-Hamber Dynax S50 £40.80 for 5 litres

The vertical lines are very much in evidence on the surface. The big surprise was the seam protection was so much better.

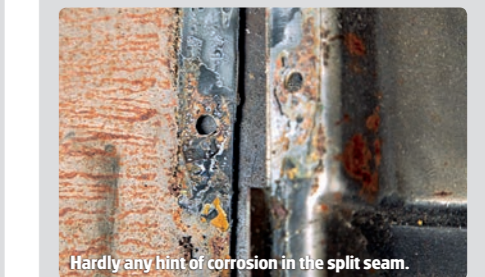
Hardly any hint of corrosion in the split seam.

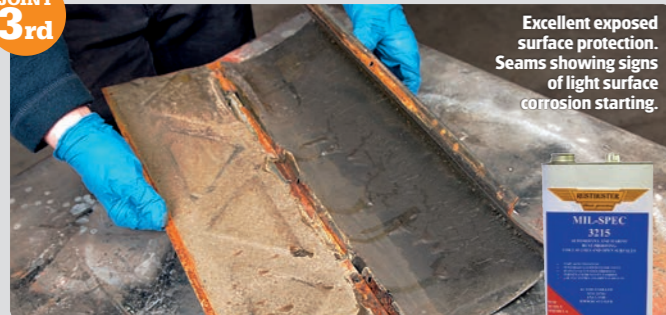
JOINT
3rd

Excellent exposed surface protection. Seams showing signs of light surface corrosion starting.

MIL-Spec 3215 £42.00 for 5 litres

Excellent protection on the surface metal, where it has become a tough coating. We had to dig into the wax with our probe to see the protected metal beneath. The split seam had plenty of rusty discoloration in the wax and the seam joint was bridged by hard wax. The seam joint didn't look good but the metal was still solid.

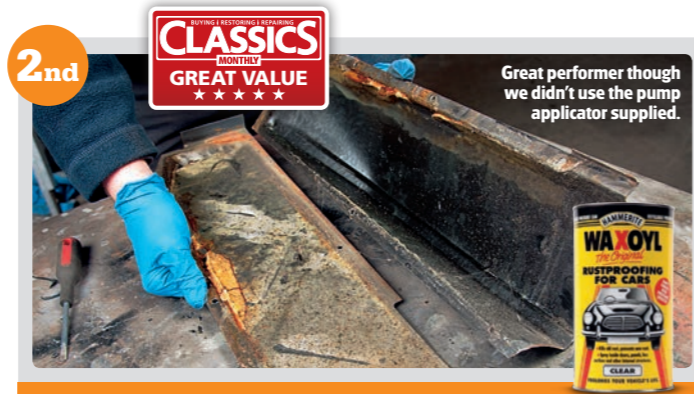
2nd

Great performer though we didn't use the pump applicator supplied.

Waxoyl £29.99 for 5 litres

The wax everyone loves to hate because it's been around so long. Well, it produced the result its reputation is built on. The surface metal was well-protected and the split seam fared equally as well. Where it sat on the surface it was still waxy to touch, even in our cold workshop. Will surprise many perhaps, but it performed admirably.

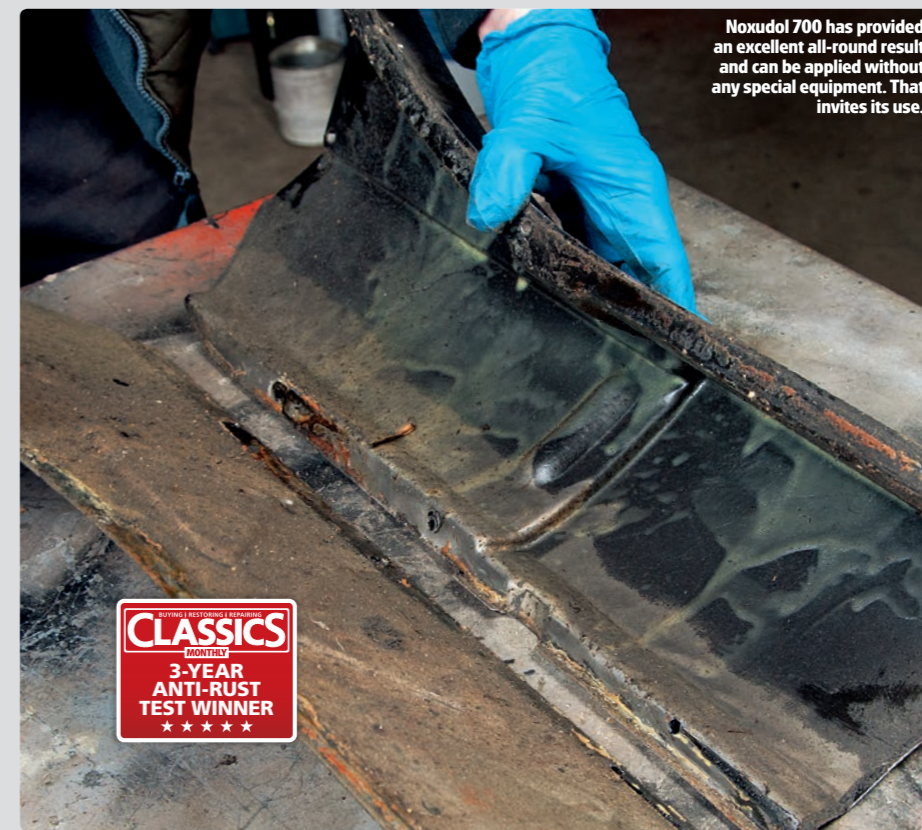
Noxudol 700 £5.58 for 500ml

The easiest product to use on test proves the most effective. This non-solvent wax delivered the result we hoped for – on the surface and in the all-important seam. It's ability to penetrate the seam and remain protective is first class. It's available as a non-aerosol too, but for enthusiasts who want an easy solution, this is surely it.

Noxudol 700 has provided an excellent all-round result and can be applied without any special equipment. That invites its use.

The winning Noxudol 700 aerosol is a true gem – a product that can be applied without any equipment or with it if non-aerosol is preferred. Noxudol's winning combination of ease of use, superb seam penetration and surface adhesion without drying out has delivered three years of protection and could be set for another three. We'll let you know.

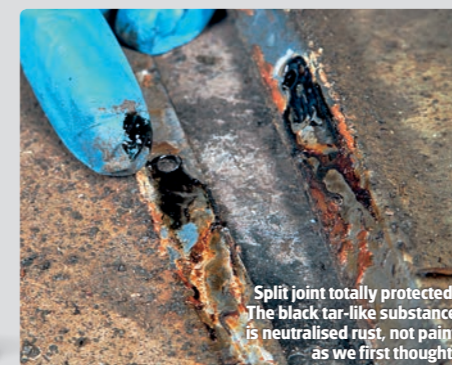
Split joint totally protected. The black tar-like substance is neutralised rust, not paint as we first thought.

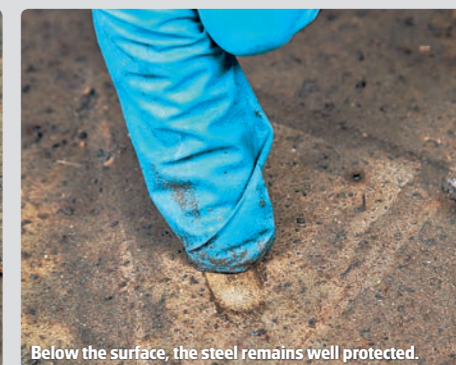
Below the surface, the steel remains well protected.
